APPRAISAL REPORT

FILE NUMBER: CO13012430  
CLAIM NUMBER: CO13012430  
DATE OF LOSS: 7/19/2013  
TYPE OF LOSS: Collision  
APPRAISED FOR: ROBERT MORINO INS. - BRIGETTE HEATH

Description: 2008 Jeep Liberty Sport  
Body Style: 4D Ut  
VIN: 1J8GN28K18W164277  
Mileage: 75,415  
OEM/ALT: A  
Color: BLACK  
Options: PASSENGER AIRBAG, DRIVER AIRBAG, POWER LOCK, POWER WINDOW, POWER STEERING  
REAR WINDOW DEFOGGER, MANUAL AIR CONDITION, CRUISE CONTROL, TILT STEERING COLUMN  
ANTI-LOCK BRAKE SYS., TRACTION CONTROL, FOG LIGHTS, ALUM/ALLOY WHEELS  
SATELLITE RADIO, 4WD OR AWD, PRIVACY GLASS, TINTED GLASS, SIDE AIRBAGS  
ANTI-THEFT SYSTEM, AUTOMATIC HEADLIGHTS, AM/FM STEREO CD/MP3 PLAYER  
ELECTRONIC STABILITY CONTROL, FRONT BUCKET SEATS, KEYLESS ENTRY SYSTEM  
POWER DISC BRAKES, REAR WINDOW WIPER

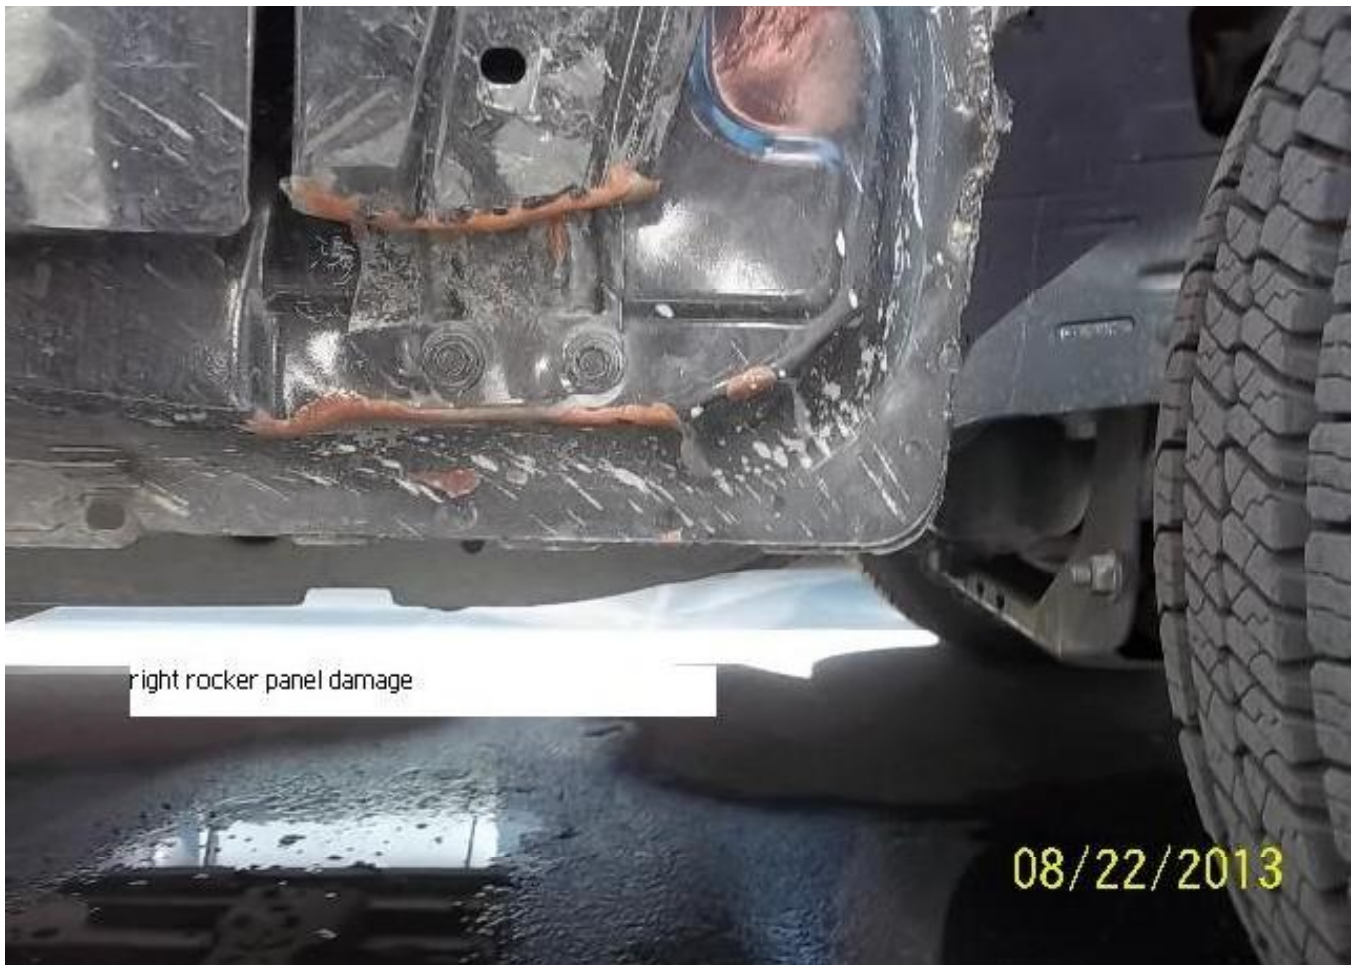
right rocker panel damage

26	101656	BDY	REMOVE/REPLACE	R Fender Rivet 6@1.60	6506007AA	9.60		
				<u>Cowl &amp; Dash</u>				
27	100433	BDY	REMOVE/INSTALL	Cowl/Dash Cover	Existing		0.7	#r
				<u>Rocker/Pillars/Floor</u>				
28	101265	BDY	REPAIR	R Section Rocker Panel			7.0*	
29		REF	REFINISH	R Rocker Panel			C 1.6	
30	100926	BDY	REMOVE/INSTALL	R Rocker Moulding			INC	
31	100538	BDY	REMOVE/REPLACE	R Rocker Moulding	1AW18RXFAD	78.25	0.8	
32	100540	BDY	REMOVE/REPLACE	R Rocker Retainer 2@6.25	6503598	12.50		
33	100552	BDY	REMOVE/INSTALL	R Lwr Ctr Pillar Trim Panel	Existing		0.3	r
				<u>Front Door</u>				
34	100940	REF	BLEND	R Frt Door Outside			C 1.0	
35	100951	BDY	REMOVE/INSTALL	R Frt Otr Belt Moulding			0.2	
36	100953	BDY	REMOVE/INSTALL	R Frt Rear View Mirror			0.7	#
37	100697	BDY	REMOVE/REPLACE	R Frt Door Adhesive Moulding	5KG82RXFAA	119.00	0.2	
38	100961	BDY	REMOVE/INSTALL	R Frt Door Trim Panel			INC	
39	100981	BDY	REMOVE/INSTALL	R Frt Otr Door Handle			0.3	#
