**View Claim Summary - File Number: 07022013-1000025**

Claim Number : CO13010850

Loss Type : Collision

Description: 2006 Acura TL Navi
Body Style: 4D Sed
VIN: 19UUA66226A070016
Mileage: 96,705
OEM/ALT: O
Color: Silver
Options: PASSENGER AIRBAG, DRIVER AIRBAG, POWER DRIVER SEAT, POWER LOCK, POWER WINDOW
REAR WINDOW DEFOGGER, CRUISE CONTROL, TILT STEERING COLUMN, LEATHER SEAT
POWER PASSENGER SEAT, TELESCOPIC STEERING COLUMN, ANTI-LOCK BRAKE SYS.
TRACTION CONTROL, FOG LIGHTS, ALUM/ALLOY WHEELS, NAVIGATION SYSTEM
HIGH INTENSITY DISCHARGE HEADLIGHTS, LEATHER STEERING WHEEL, SATELLITE RADIO
FRONT AIR DAM, TINTED GLASS, AUTO AIR CONDITION, TRIP COMPUTER, SUBWOOFER
UNIVERSAL GARAGE DOOR OPENER, VARIABLE ASSISTED STEERING, SIDE AIRBAGS
ANTI-THEFT SYSTEM, AUTOMATIC HEADLIGHTS
INTERIOR AUTOMATIC DAY/NIGHT OR ELECTROCHROMATIC MIRROR
SIDE HEAD CURTAIN AIRBAGS, AM/FM STEREO CASSETTE/CD CHANGER
DRIVER HEATED MEMORY SEAT, ELECTRONIC STABILITY CONTROL, EXTERIOR MEMORY MIRRORS
FRONT HEATED BUCKET SEATS, FRONT SEATS WITH POWER LUMBAR SUPPORT

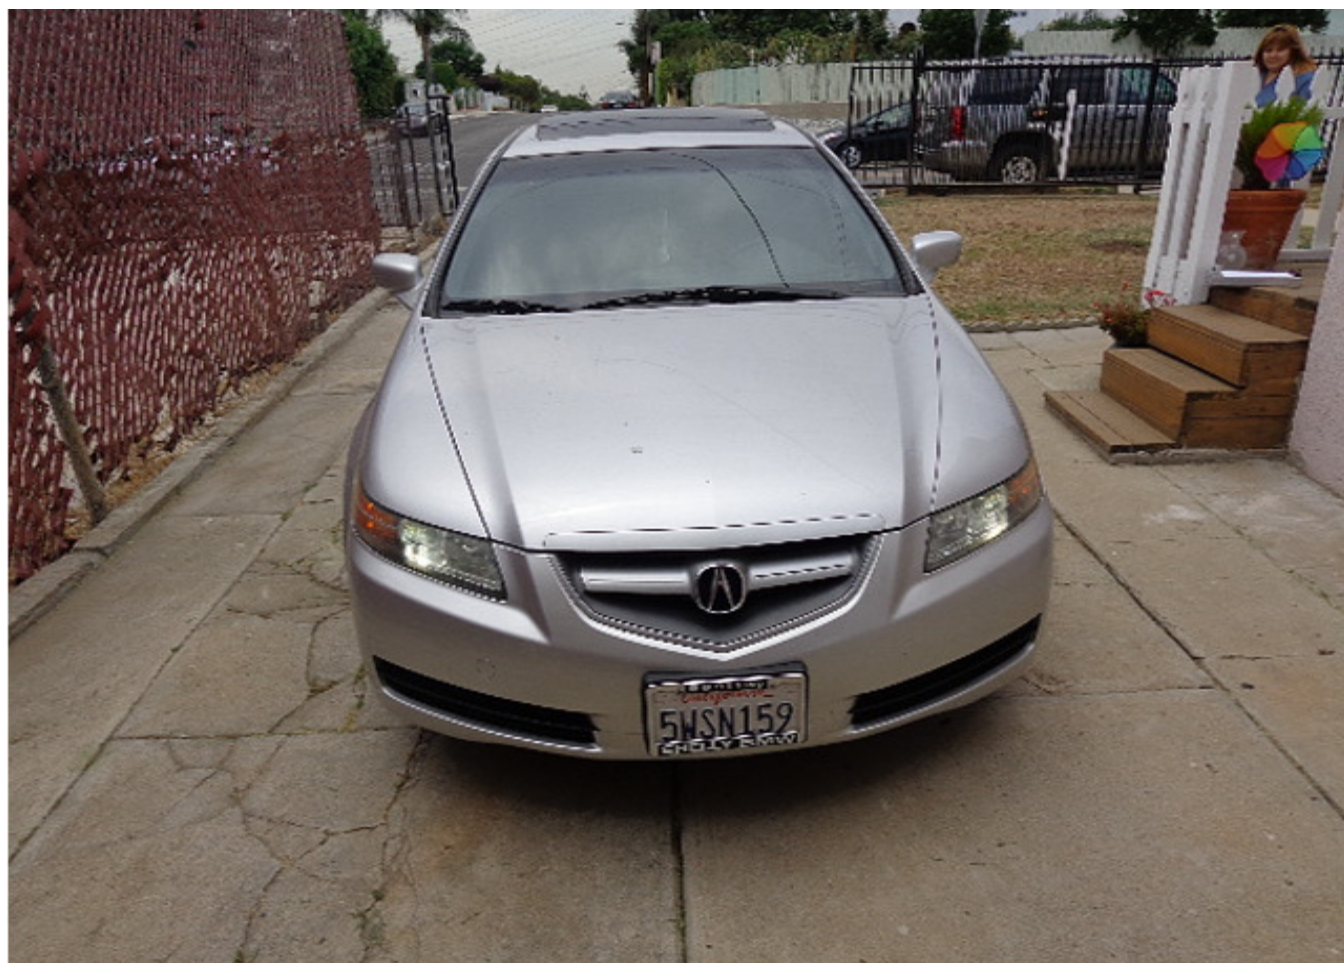
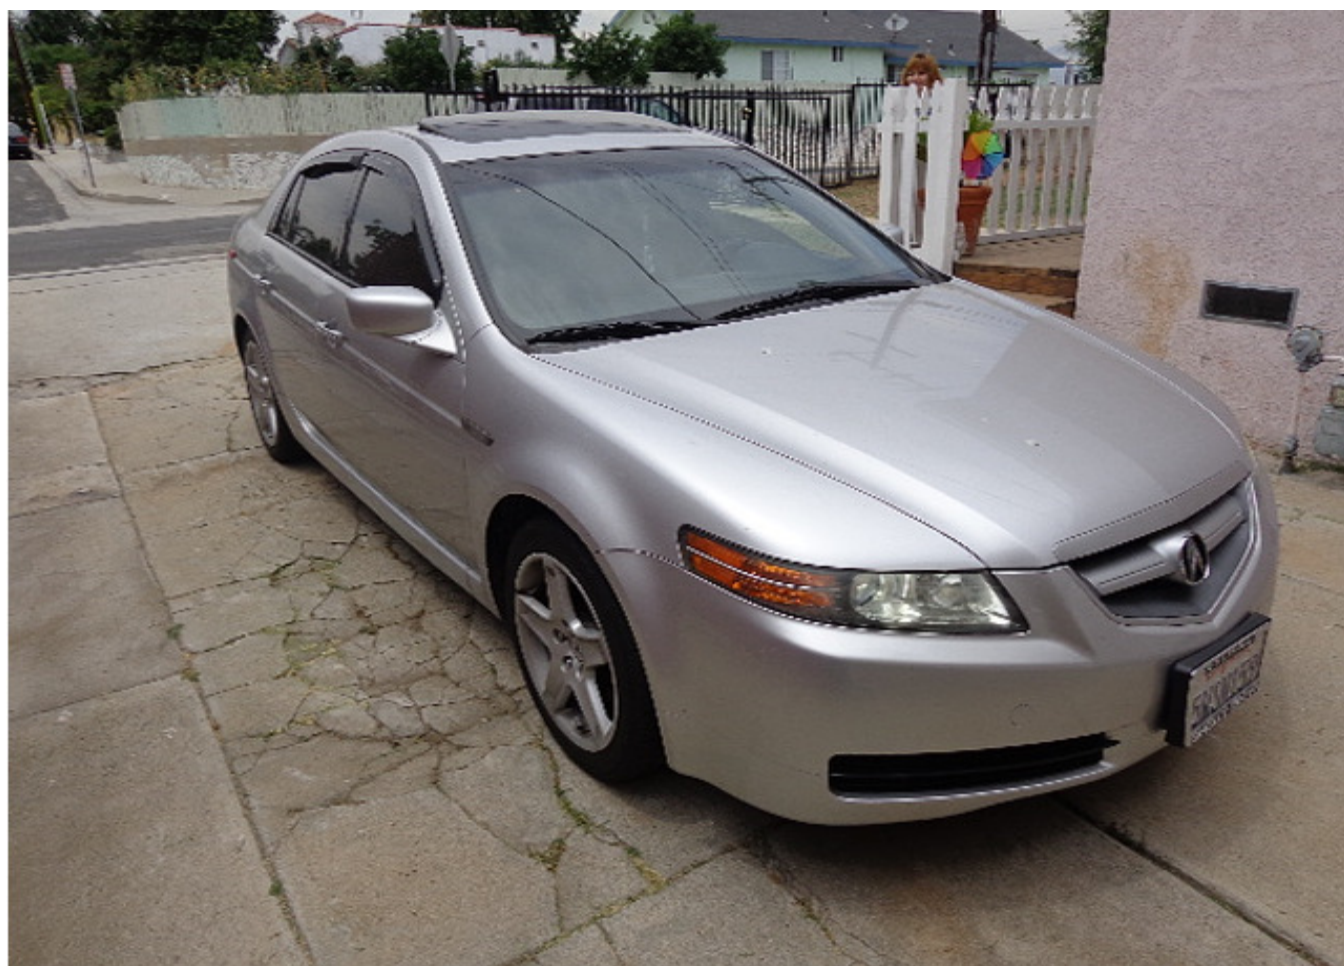
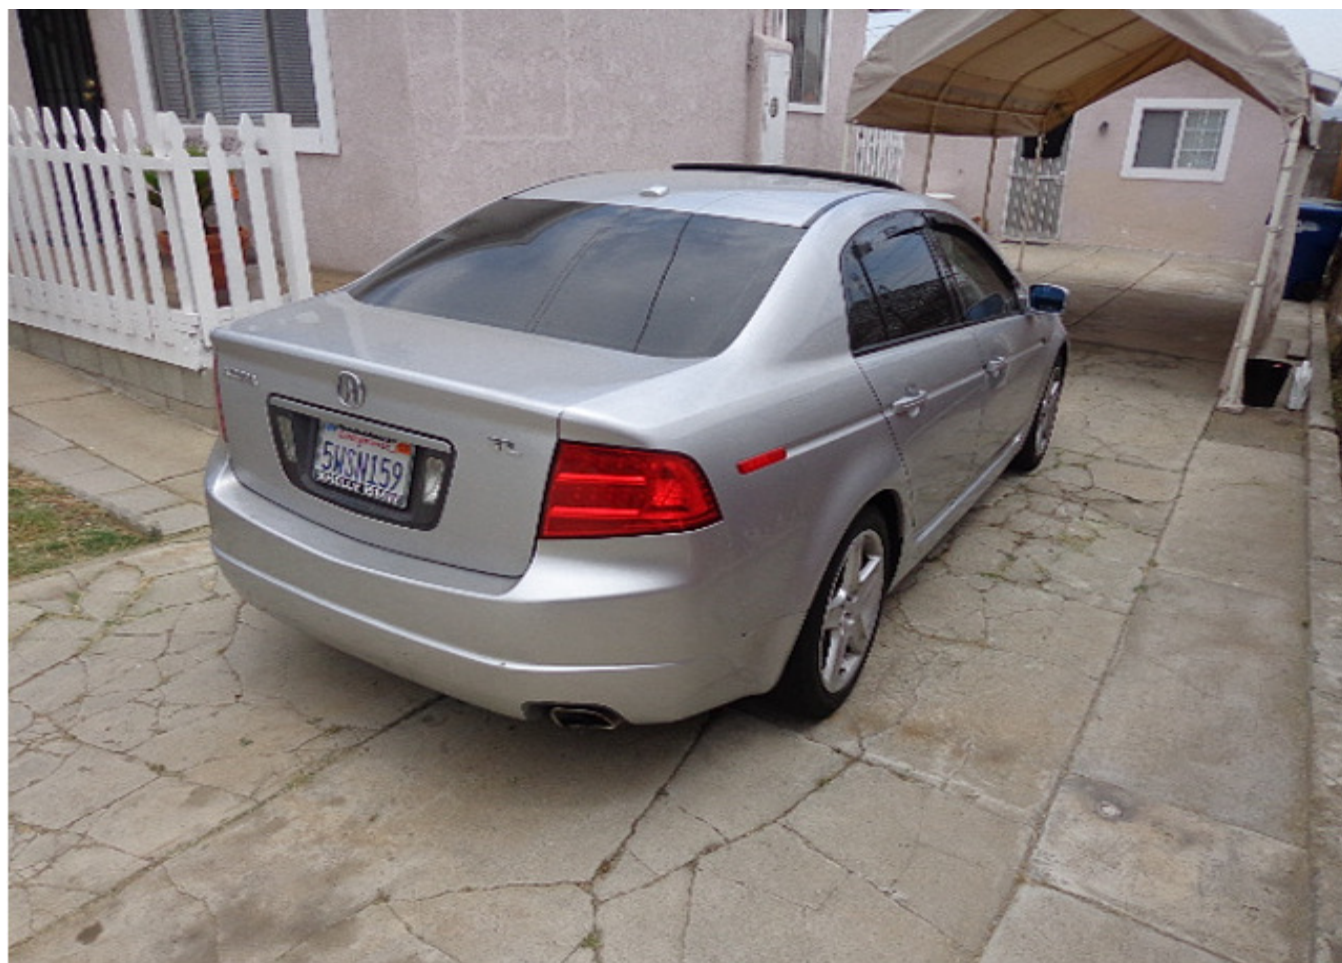
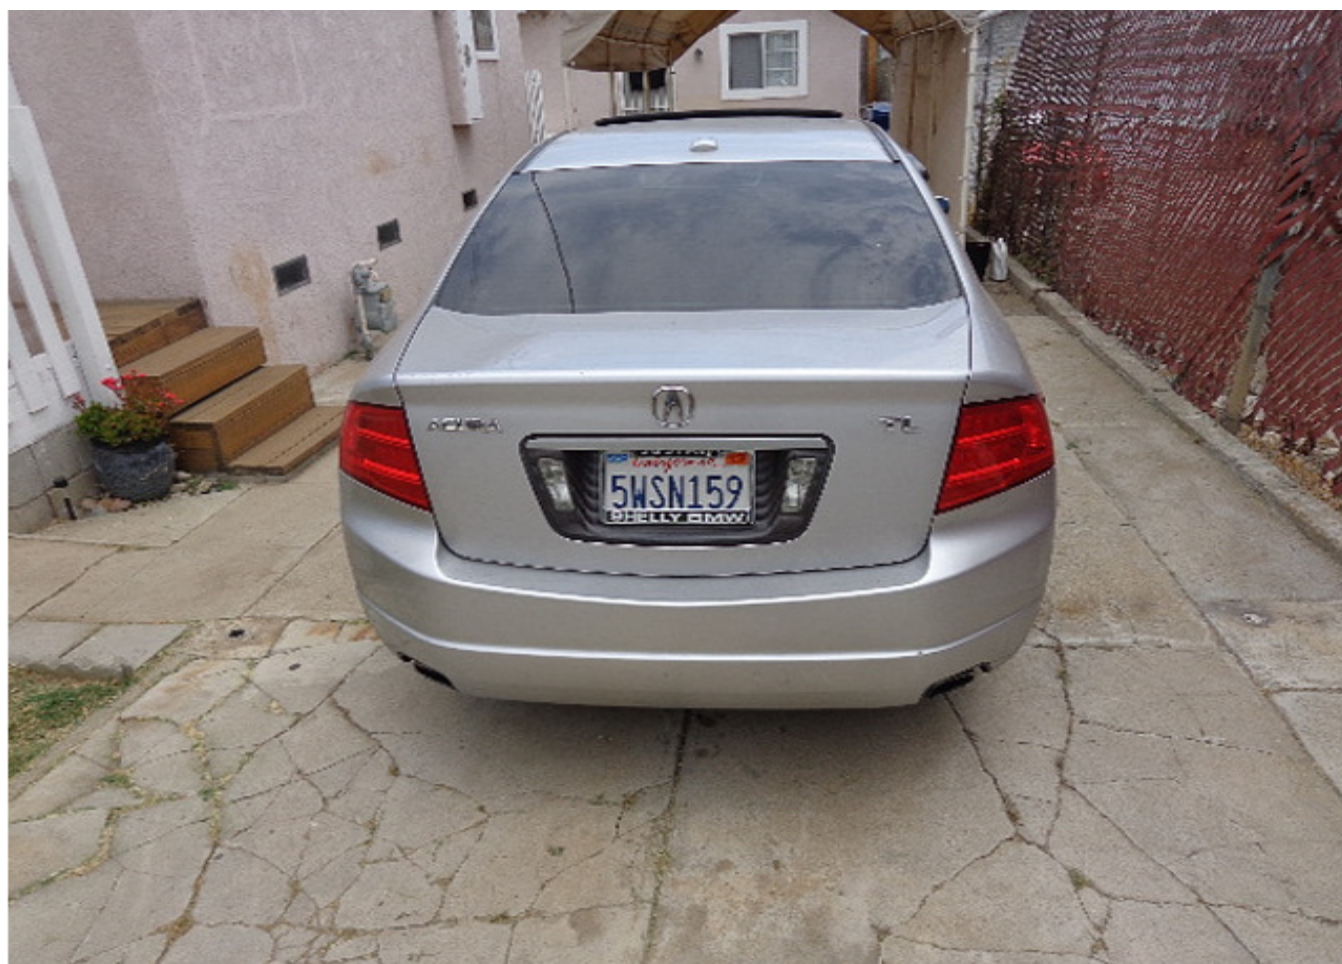
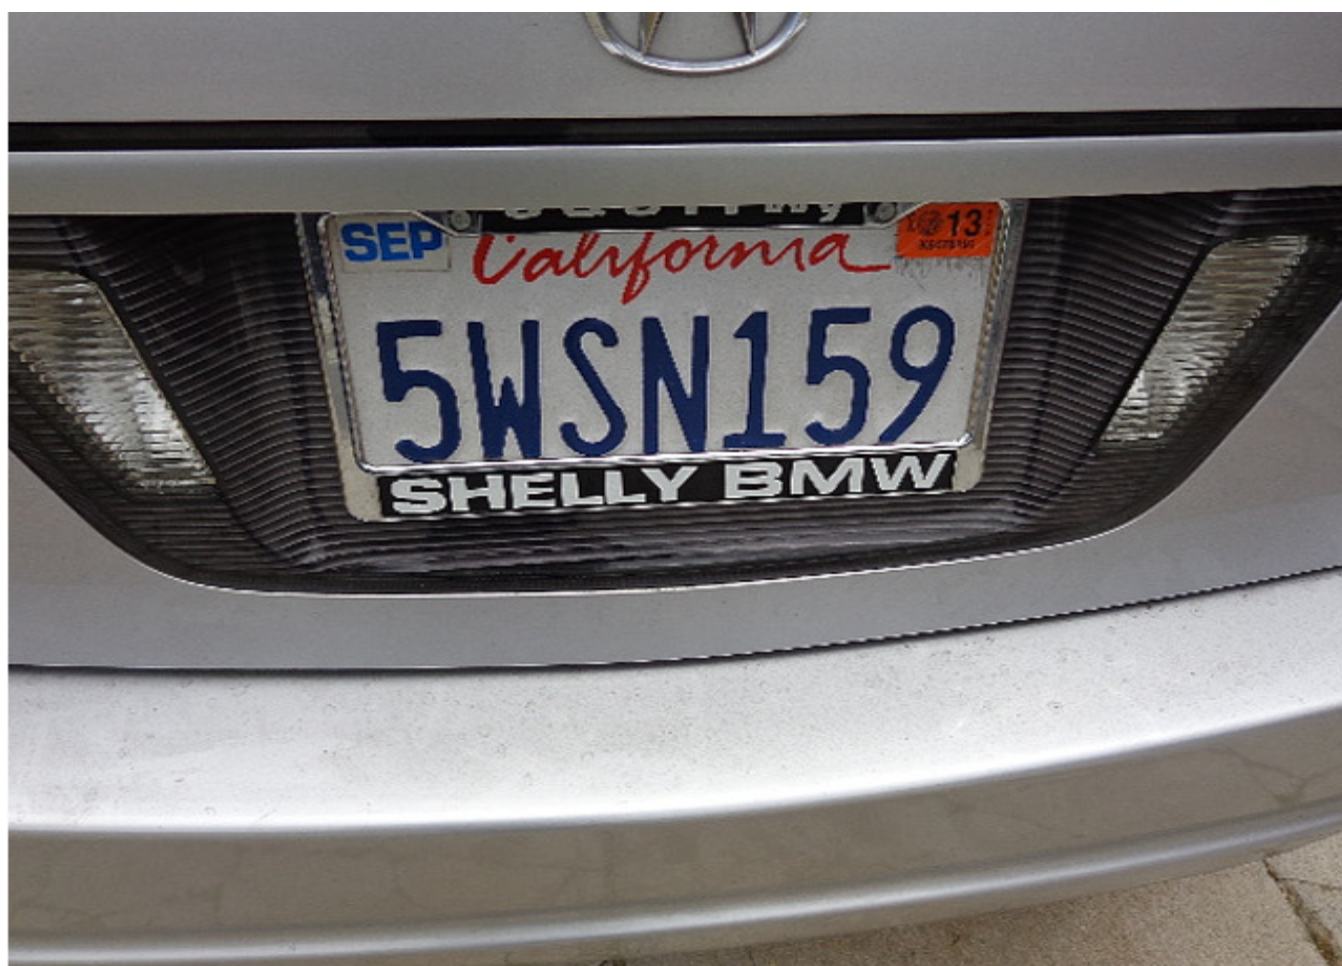
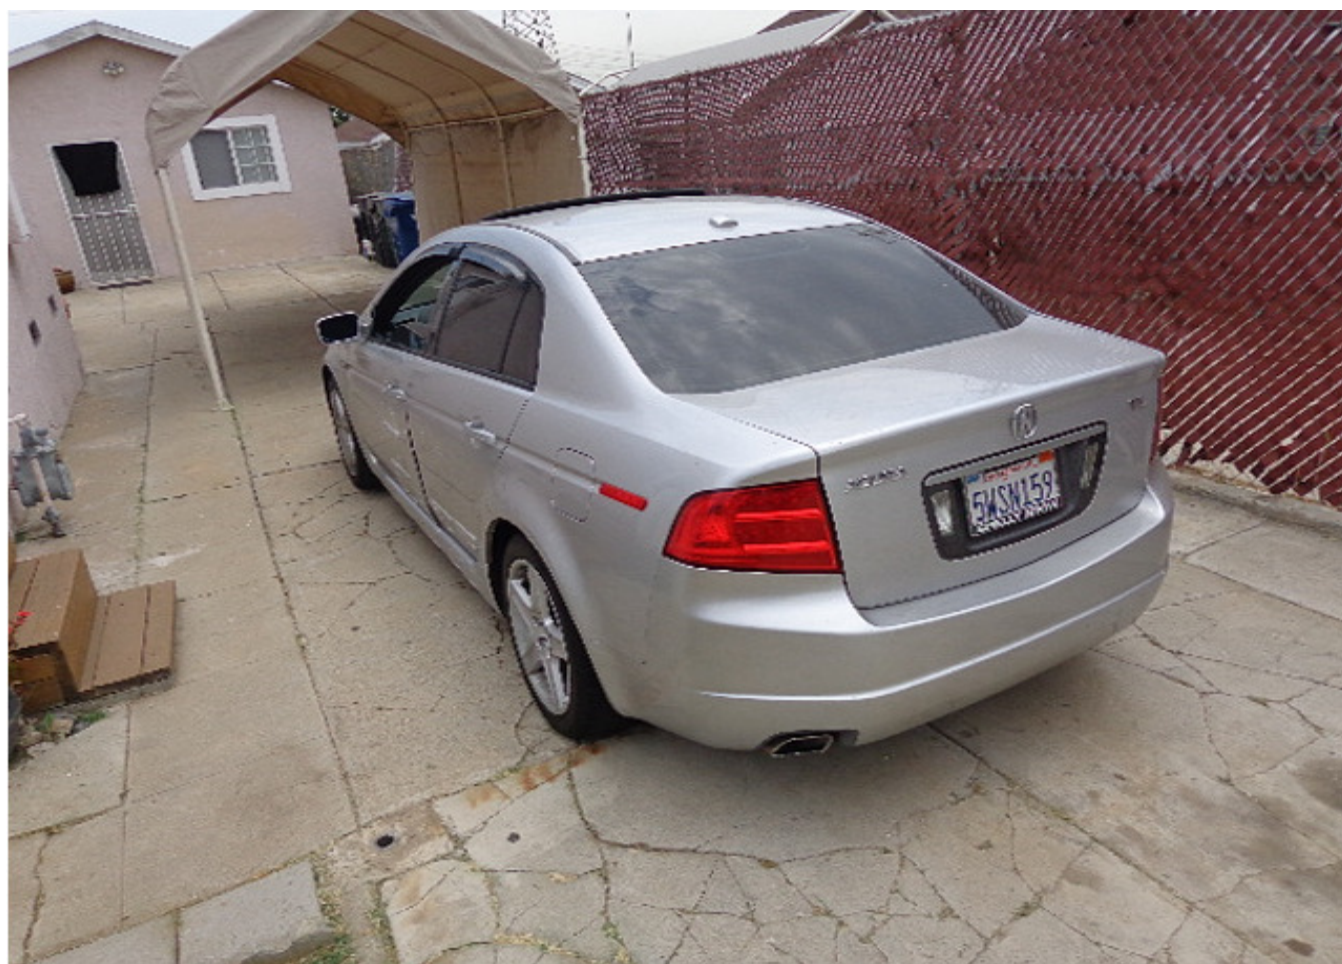
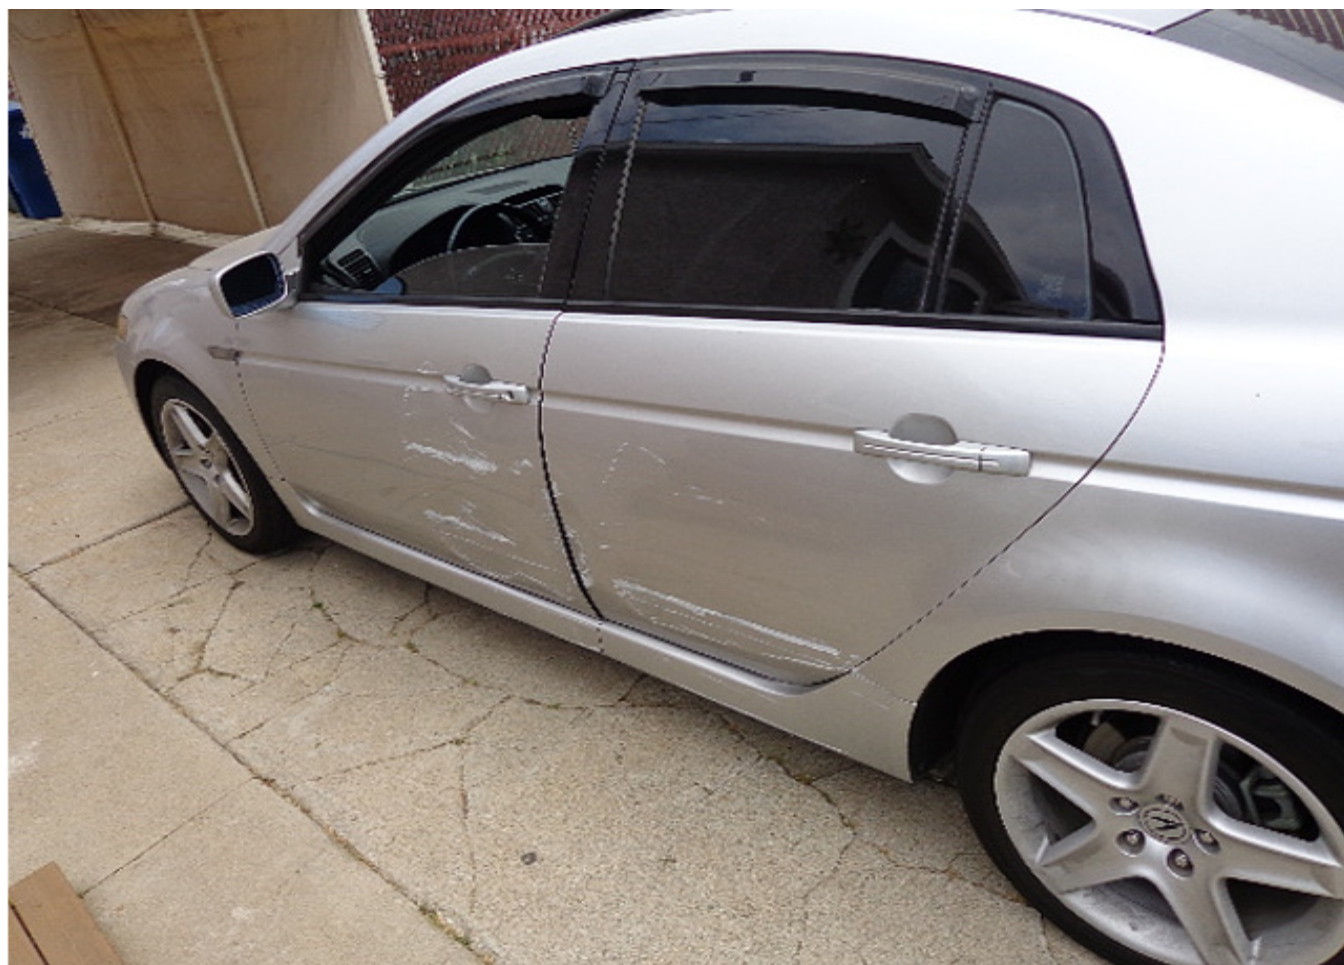
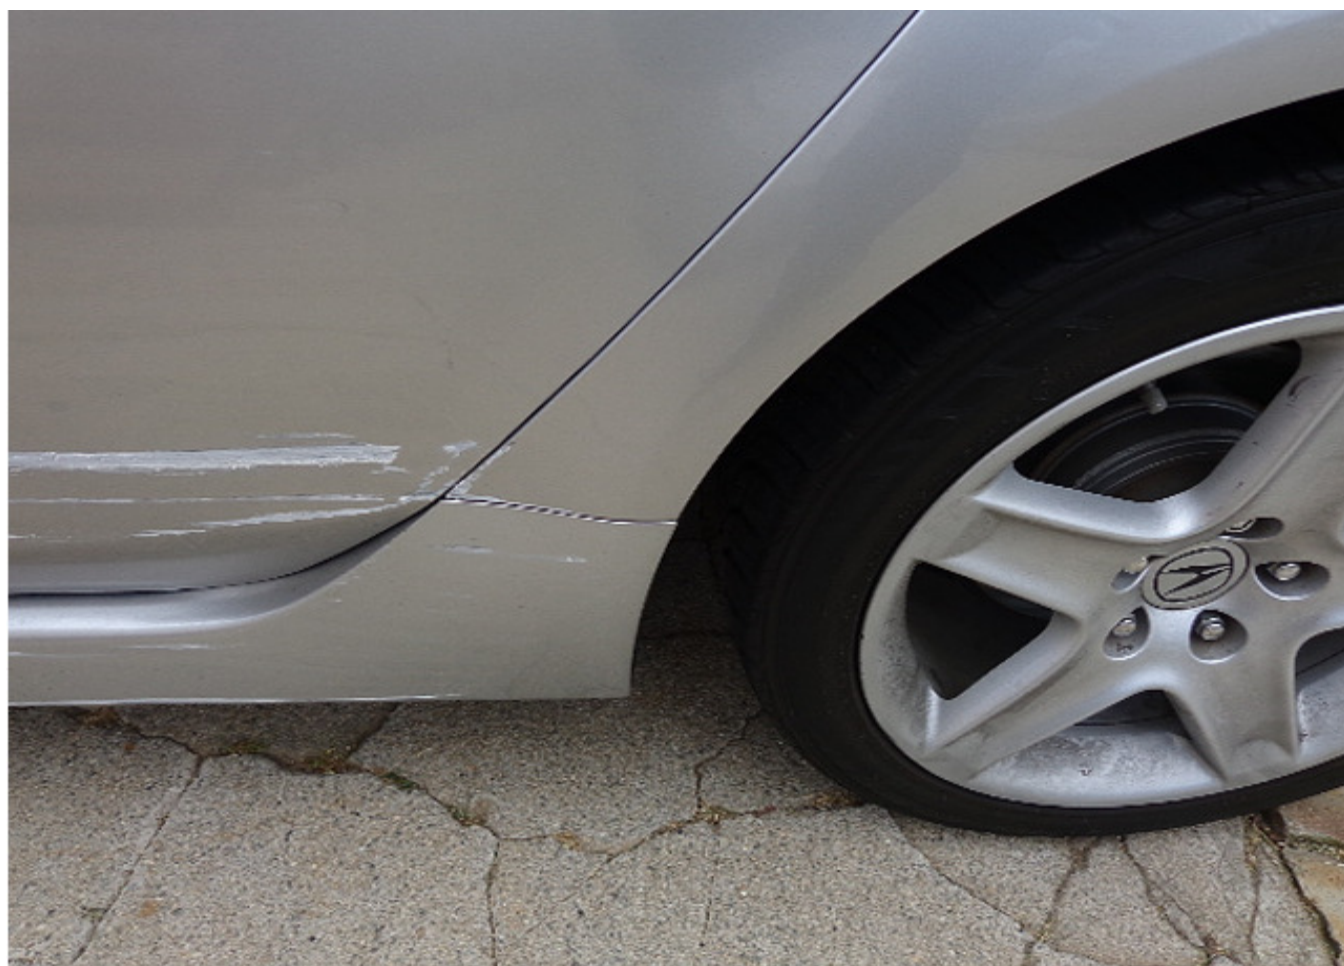
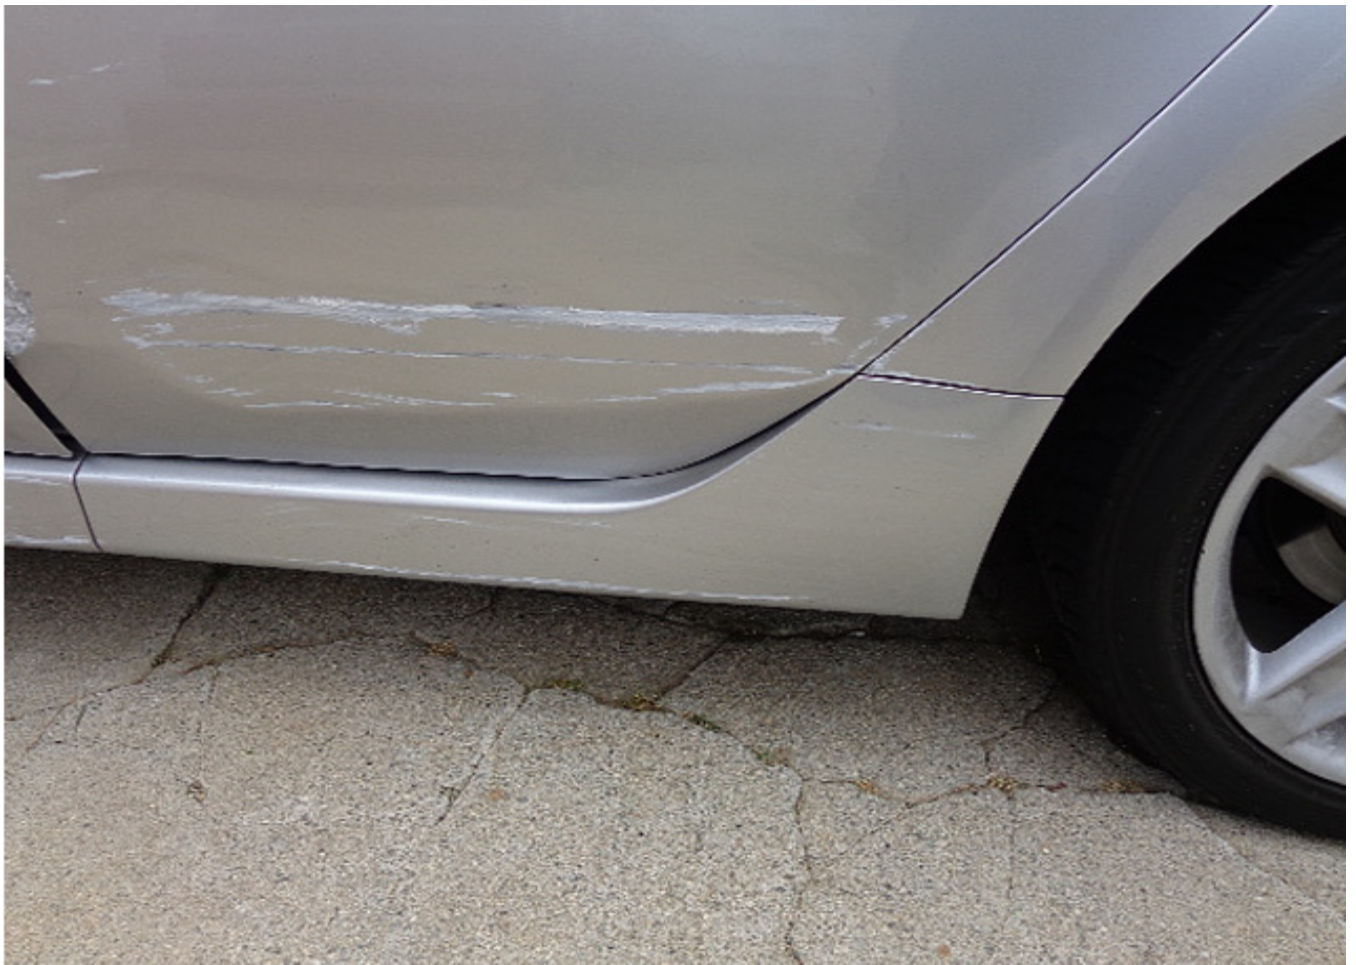
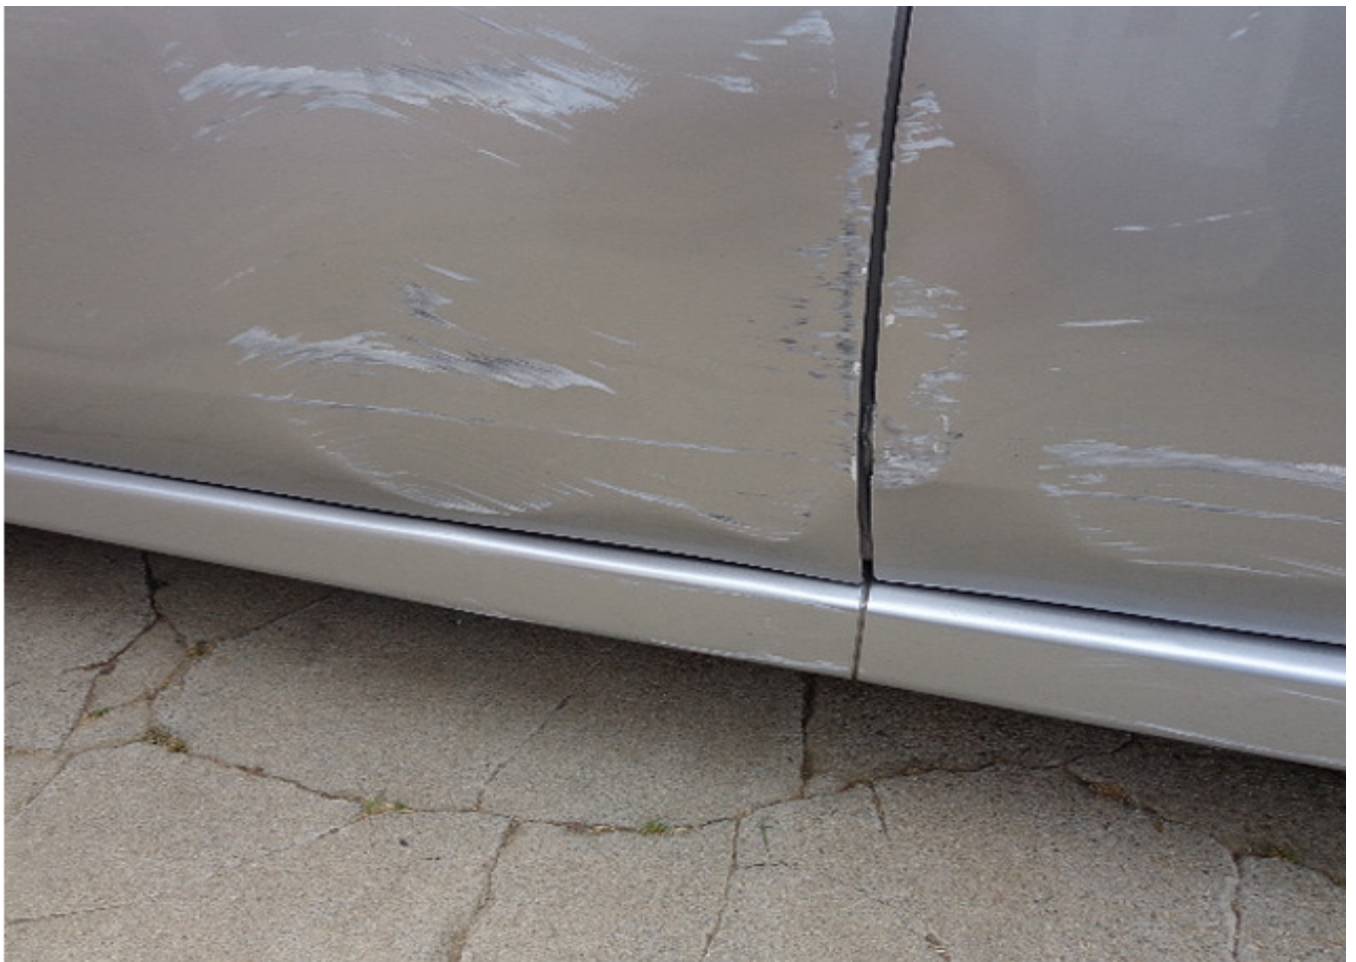
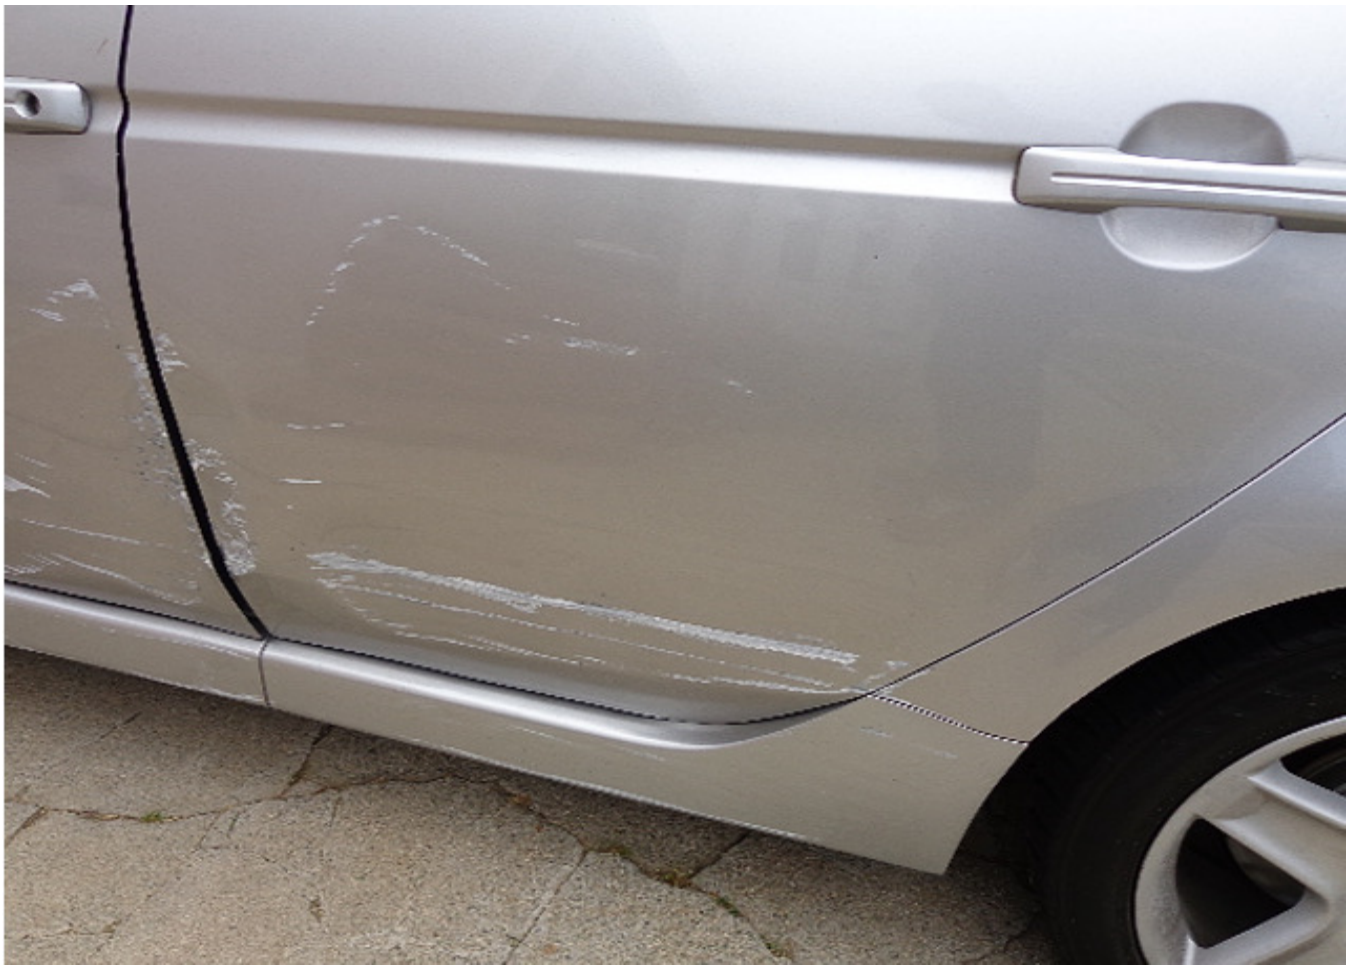
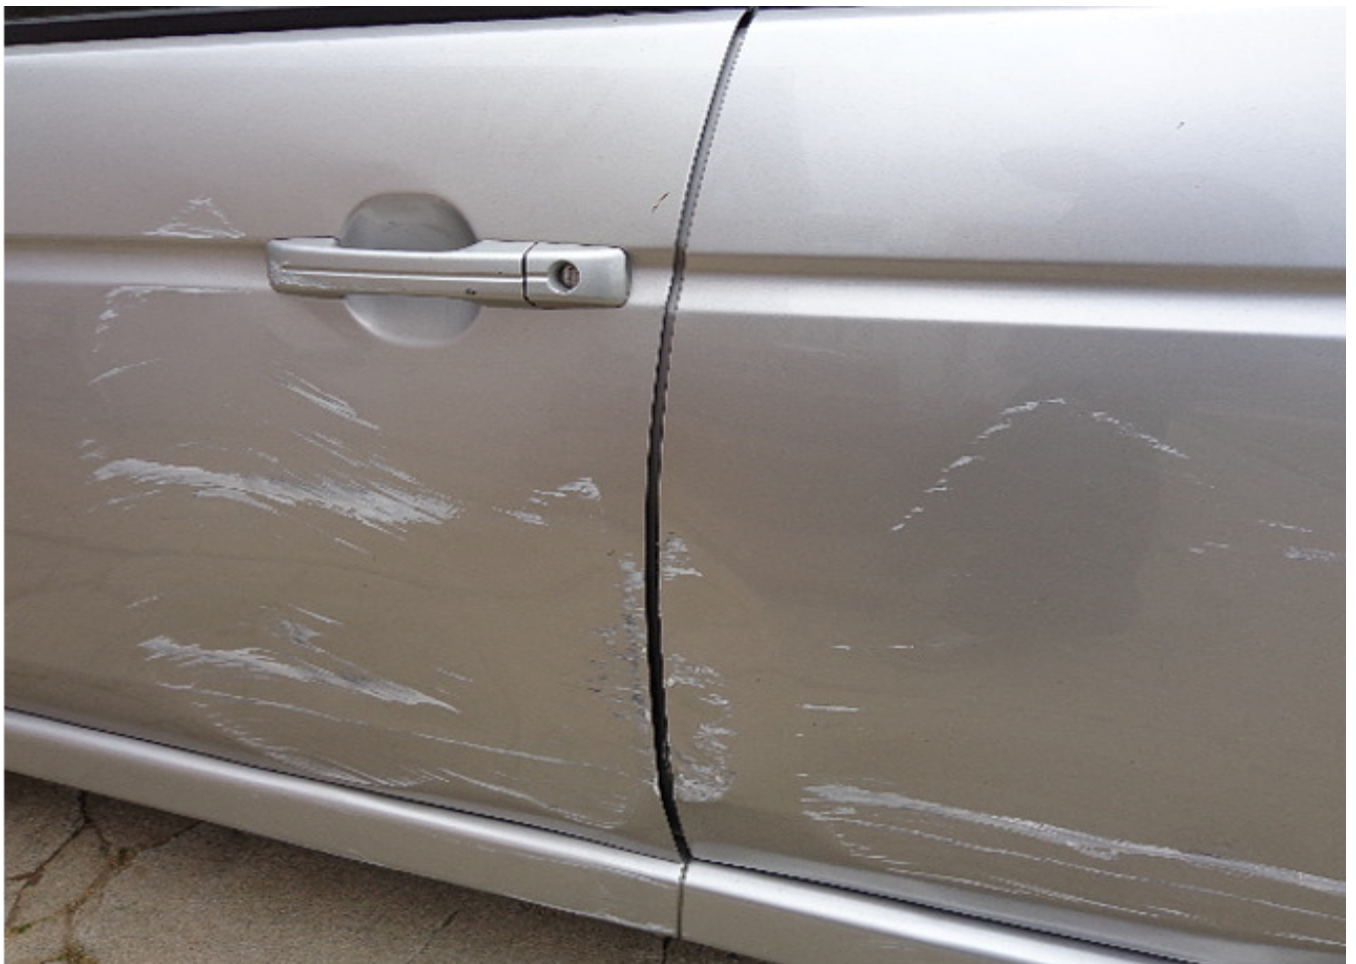
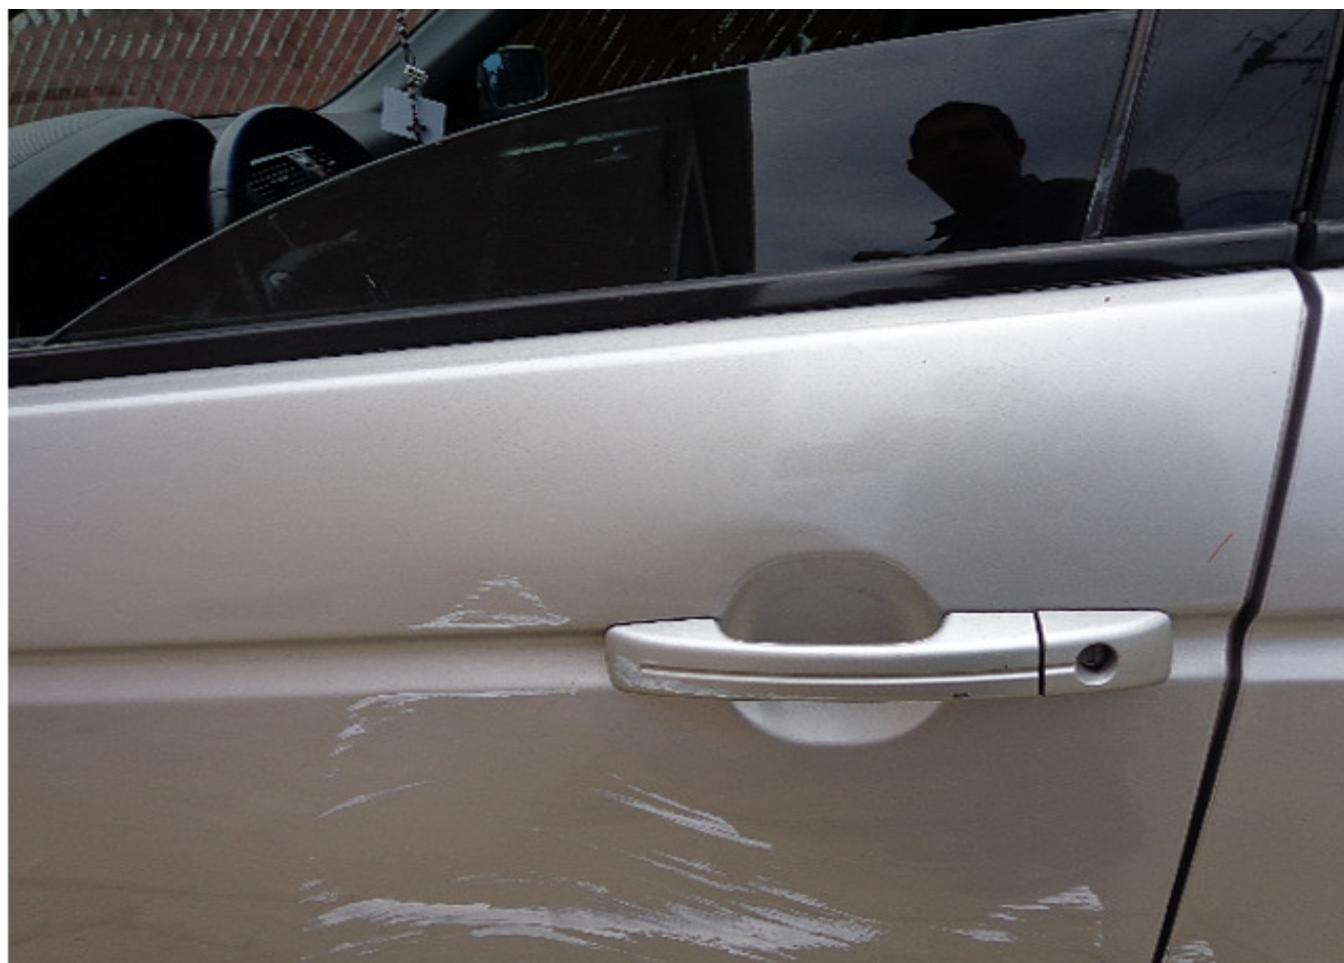
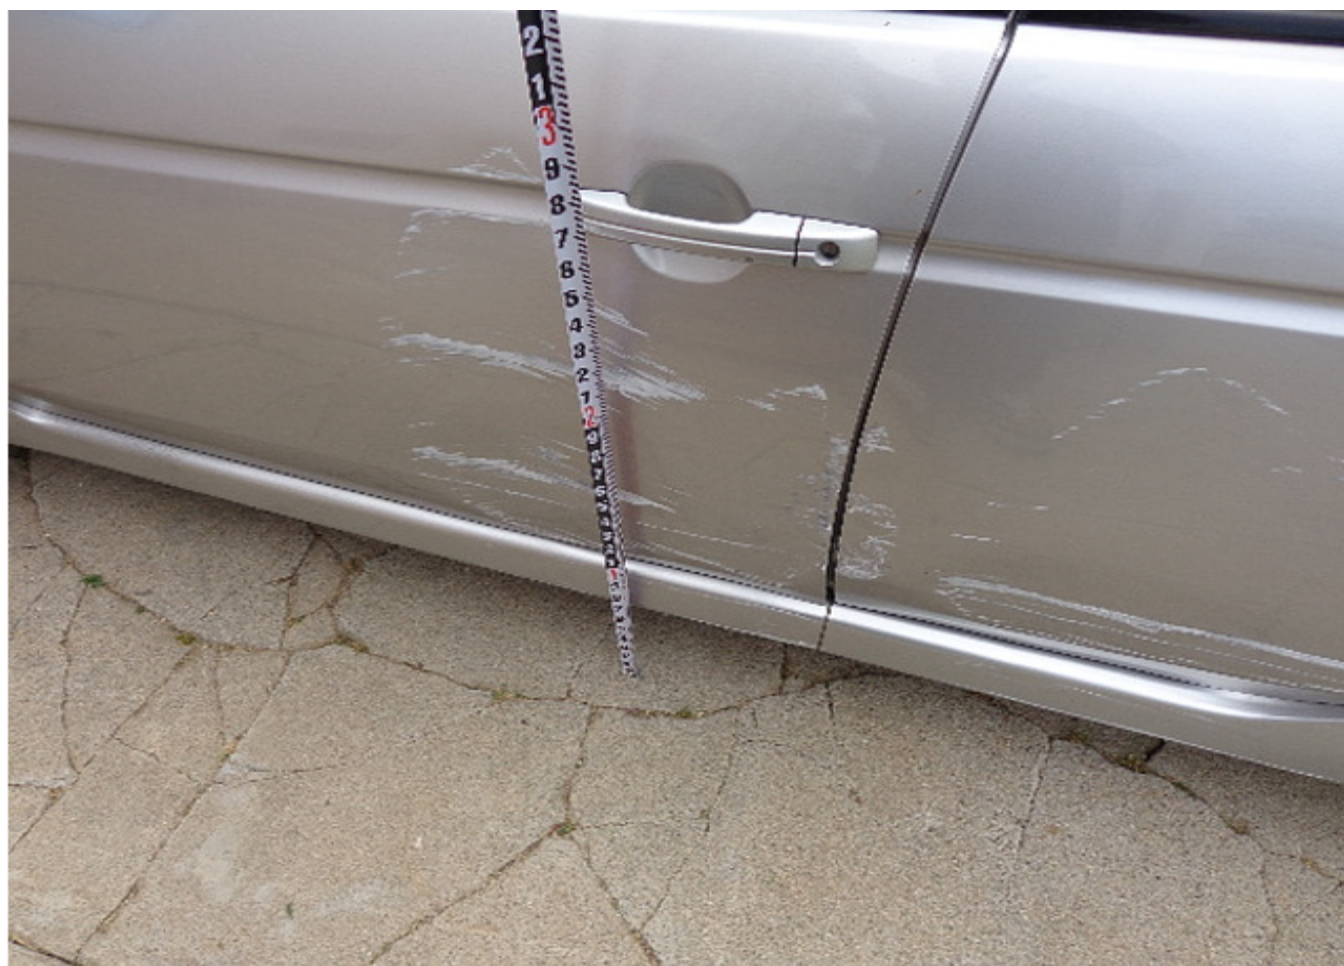
The vehicle was inspected at the owners residence on 7/3/2013 at 2:30p. There may be possible hidden damage after the vehicle is torndown.

The vehicle is repairable at this time. I was unable to photo the vehicle registration, the registration was not available at the time of inspection;

A photo of the glove box is attached to support. The estimated days to repair are 6 and please call 909-917-6777 if you have any questions.

8 Left Rear Side (P)

Line Item	Entry Number	Labor Type	Operation	Line Item Description	Part Type/ Part Number	Dollar Amount	Labor Units	CEG Unit
<u>Front Bumper</u>								
1	002079	BDY	REMOVE/INSTALL	Frt Bumper Cover			INC #	1.2
<u>Front Lamps</u>								
2	002083	BDY	CHECK/ADJUST	Headlamps			0.4	0.4
3	002085	BDY	REMOVE/INSTALL	L Frt Combination Lamp			1.5 #	1.5
4	002087	BDY	REMOVE/INSTALL	L Frt Side Marker Lamp			0.3 #	0.3
<u>Front Fender</u>								
5	002144	REF	BLEND	L Fender Outside			1.0*	2.0
6	000210	BDY	REMOVE/INSTALL	L Fender Liner	Existing		0.4 #r	0.4
7	000222	BDY	REMOVE/INSTALL	L Upr Fender Garnish	Existing		0.2 r	0.2
<u>Windshield</u>

8	002168	GLS	REMOVE/INSTALL	Windshield						
9				Rope/Mask Only						
				<u>Rocker/Pillars/Floor</u>						
10	002254	REF	BLEND	L Roof Rail				0.8*	1.6	
11	002182	REF	REFINISH	L Frt Rocker Moulding				C 1.2	1.2	
12	002184	REF	REFINISH	L Rear Rocker Moulding				C 1.0	1.0	
13	002186	BDY	REMOVE/INSTALL	L Frt Rocker Moulding				INC	0.3	
14	002188	BDY	REMOVE/INSTALL	L Rear Rocker Moulding				0.5 #	0.5	
15	002673	BDY	REPAIR	L Frt Rocker Moulding	Existing			0.0*	0.3	
16	002675	BDY	REPAIR	L Rear Rocker Moulding	Existing			3.0* #	0.5	
				<u>Front Door</u>						
17	002734	BDY	REMOVE/REPLACE	L Frt Door Shell	Qual Recycled Part		650.00 *	6.0 #	6.0T	
18		REF	REFINISH	L Frt Door Outside				C 2.0	2.0	
19		REF	REFINISH	L Frt Add For Jambs & Interior				C 1.0	1.0	
20				One Way Auto, 626-289-6126, 98395						
21				Line Markup %20.00			130.00			
22	002206	BDY	REMOVE/INSTALL	L Frt Door Mirror				INC #	0.7	
23	002211	BDY	REMOVE/INSTALL	L Frt Door Trim Panel				INC	0.4

24	002219	BDY	REMOVE/INSTALL	L Frt Otr Door Handle				INC #	0.7	
25	002758	BDY	REMOVE/REPLACE	L Frt Door Outside Handle	Qual Recycled Part			INC*	INC #r	0.3T
26	002762	BDY	REMOVE/REPLACE	L Frt Otr Door Handle Cover	Qual Recycled Part			INC*	INC #	0.3T
				<u>Rear Door</u>						
27	001411	BDY	REMOVE/REPLACE	L Rear Door Shell	Qual Recycled Part		500.00 *	5.5 #	5.5T	
28		REF	REFINISH	L Rear Door Outside				C 1.6	2.0	
29		REF	REFINISH	L Rear Add For Jambs & Interior				C 1.0	1.0	
30				One Way Auto, 626-289-6126, 98395						
31				Line Markup %20.00			100.00			
32	002239	BDY	REMOVE/INSTALL	L Rear Door Trim Panel				INC	0.4	
33	002247	BDY	REMOVE/INSTALL	L Rear Otr Door Handle				INC #	0.7	
				<u>Roof</u>						
34	002252	BDY	REMOVE/INSTALL	L Roof Moulding				0.3	0.3	
				<u>Back Window</u>						
35	002259	GLS	REMOVE/INSTALL	Back Window				0.5* #	2.5	
36				Rope/Mask Only						
				<u>Quarter Panel</u>						
37	002266	REF	BLEND	L Fuel Door				0.3* #	0.5

38	004075	BDY	REPAIR	L Quarter Outer Panel	Existing			2.0* #	16.0	
39		REF	REFINISH	L Quarter Panel Outside				C 1.6	2.0	
40	001682	BDY	REMOVE/INSTALL	L Quarter Fuel Door	Existing			0.2 #r	0.2	
				<u>Rear Lamps</u>						
41	002286	BDY	REMOVE/INSTALL	L Rear Lens & Housing				0.3	0.3	
				<u>Rear Bumper</u>						
42	002291	BDY	REMOVE/INSTALL	Rear Bumper Assy				0.8	0.8	
				<u>ADDITIONAL OPERATIONS</u>						
43		REF	ADD'L OPR	Clear Coat				2.5		
44	933003	BDY *	ADD'L OPR	Tint Color				0.5*		
45	933018	BDY *	ADD'L OPR	Mask For Overspray			5.00 *	0.3*		
				<u>Additional Costs & Materials</u>						
46			ADD'L COST	Paint/Materials			420.00 *			T
47			ADD'L COST	Hazardous Waste Disposal			3.00 *			T
